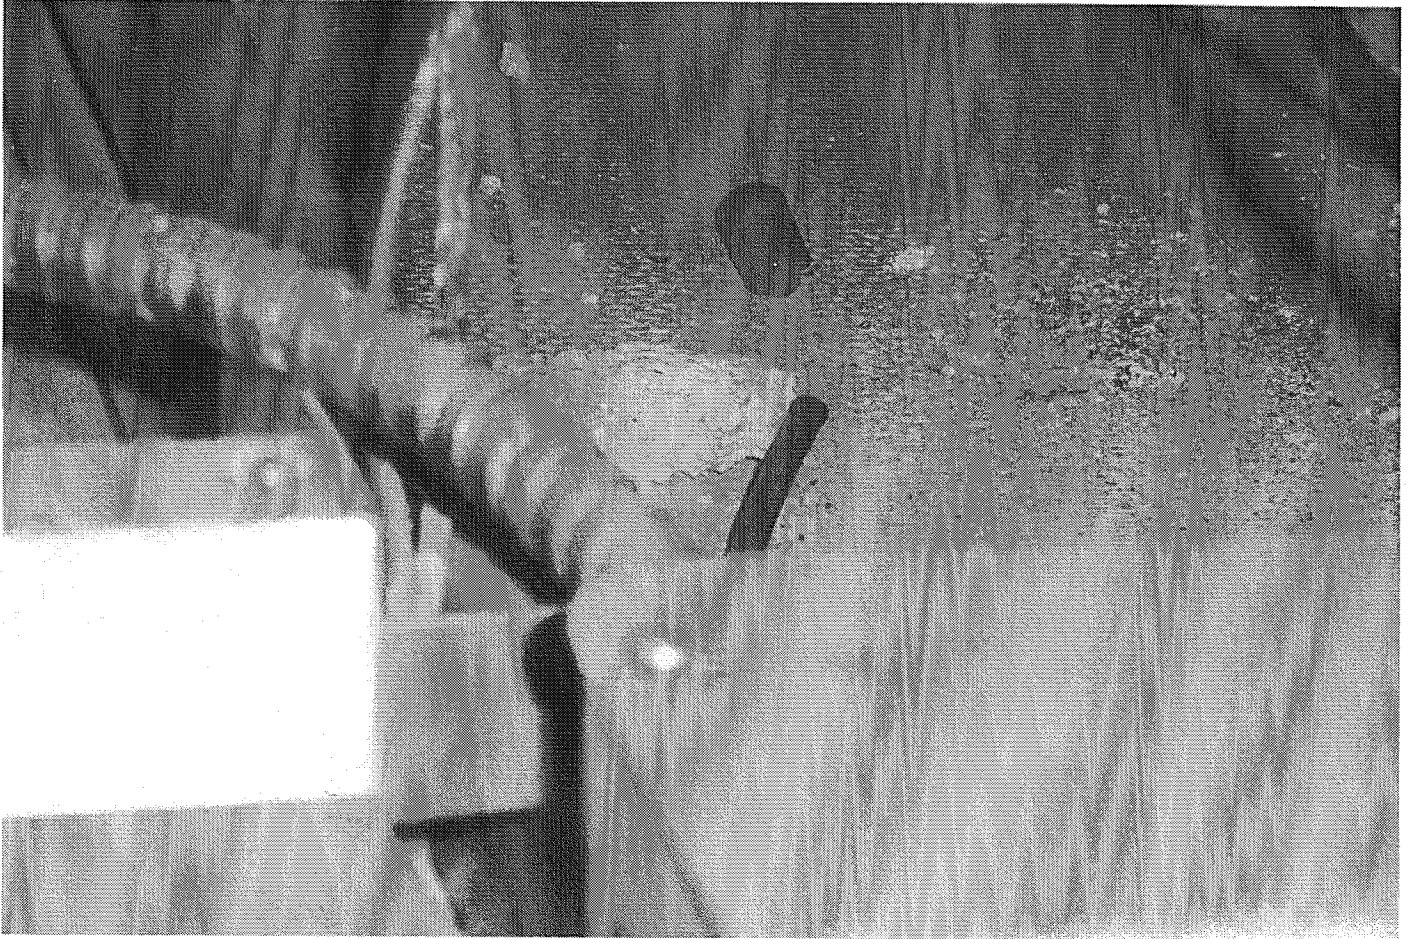
36. 17th floor, adjacent to room S1704A - Close-up of delaminated fireproofing debris on top of suspended ceiling

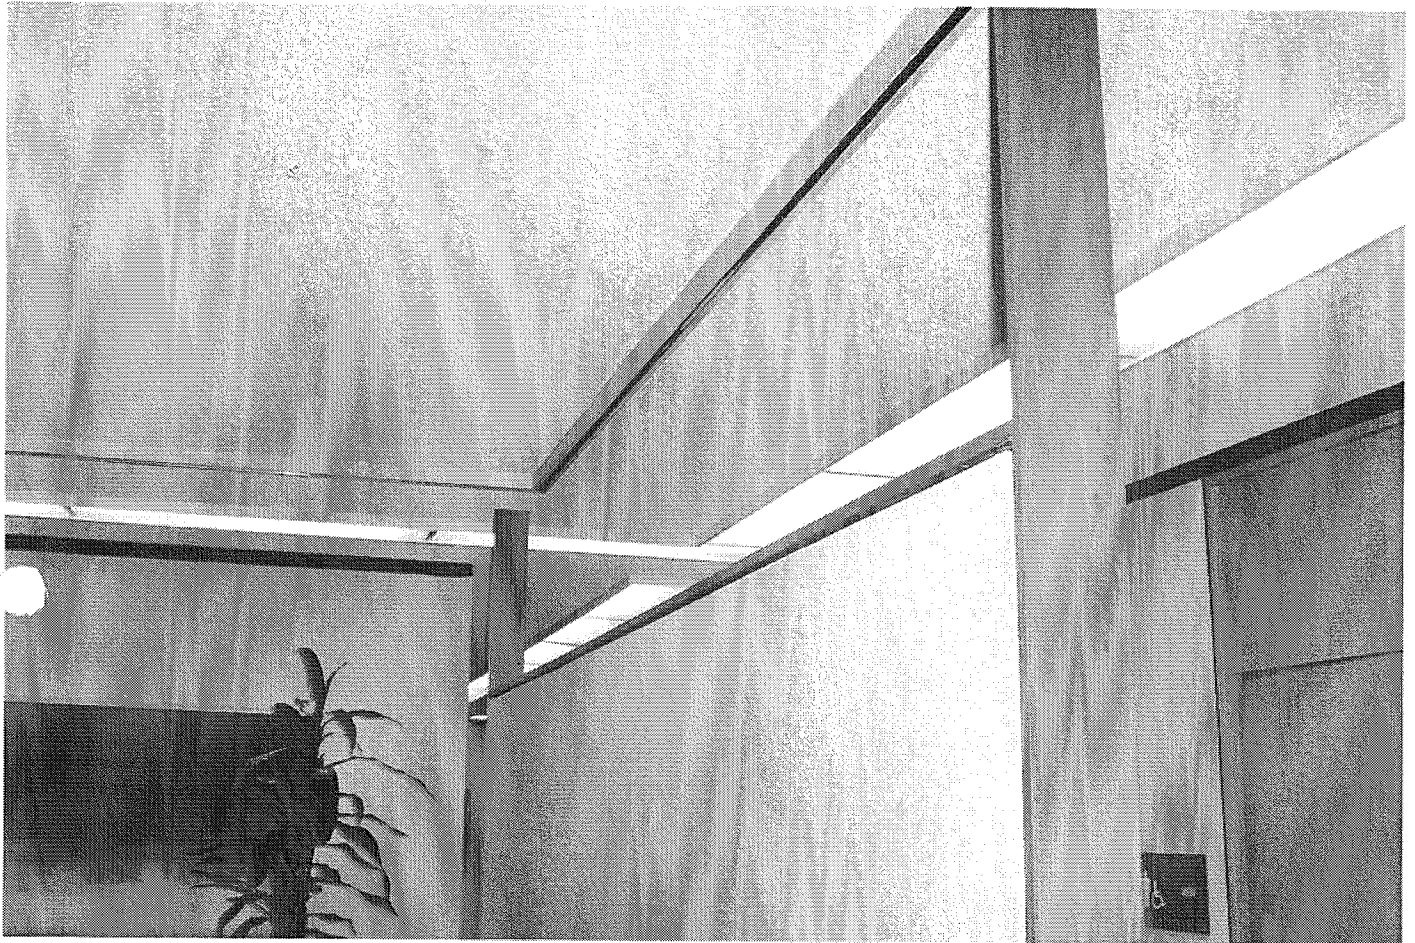
37. 17th floor, elevator lounge area - General view of partition wall located beneath acoustical spray ceiling

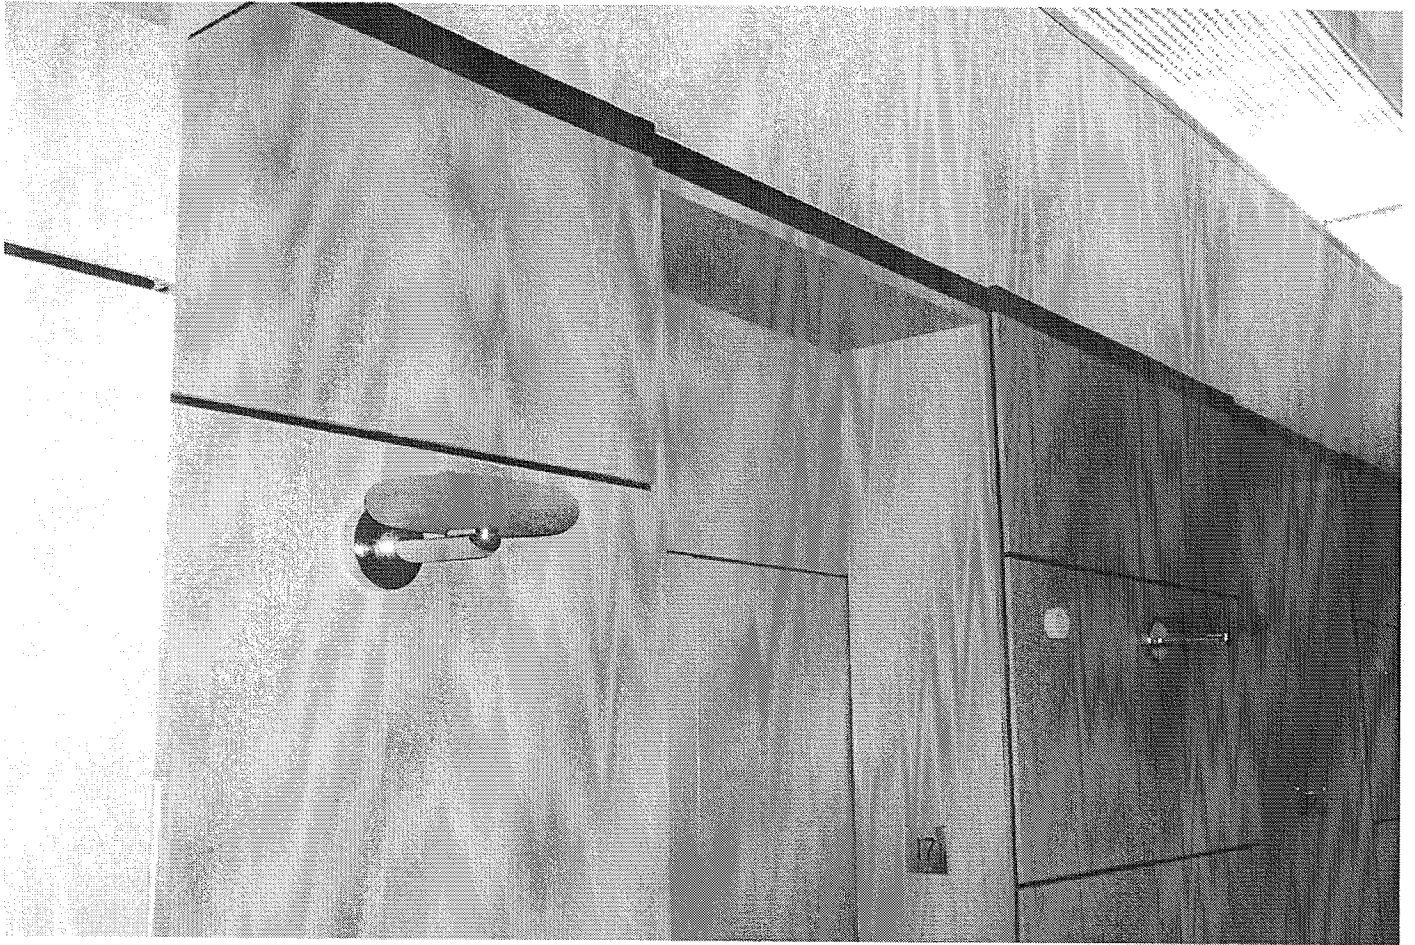
38. 17th floor, elevator lounge area - General view of accoustical spray ceiling above elevators

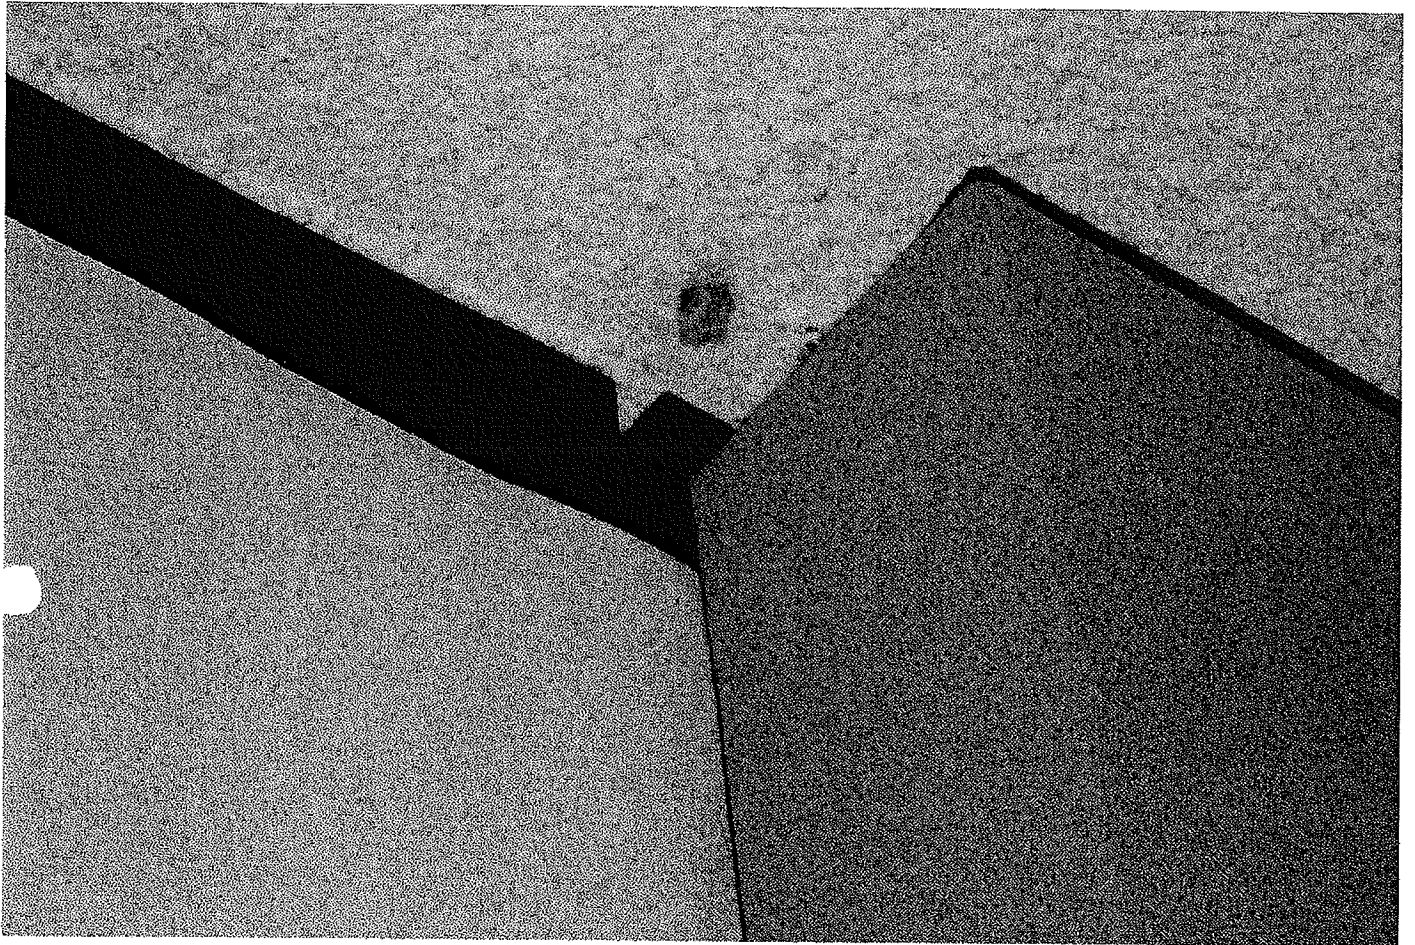
39. 17th floor, elevator lounge area - Close-up of hole in acoustical sprayed ceiling
